DEPARTMENT OF TRANSPORTATION**DIVISION OF ENGINEERING SERVICES**

Contract #: 04-0120F4Cty: SF/ALA Rte: 80 PM: 13.2/13.9File #: 69.28**WELDING INSPECTION REPORT****Resident Engineer:**Pursell, Gary**Address:** 333 Burma Road**City:** Oakland, CA 94607**Report No:** WIR-002002**Date Inspected:** 23-Apr-2008**Project Name:** SAS Superstructure**OSM Arrival Time:** 2300**Prime Contractor:** American Bridge/Fluor Enterprises, a JV**OSM Departure Time:** 730**Contractor:** Zhenhua Port Machinery Company, Ltd (ZPMC), Changxing Island **Location:** Shanghai, China

Bridge No: 34-0006**Component:** Tower**Summary of Items Observed:**

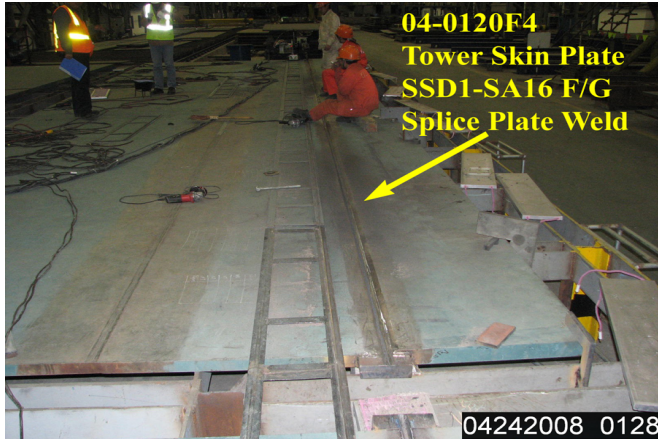
Item Description	WBS	Dwg No.	Status
1 Tower Skin Plate	NA	NA	Weld Joint Preparation

New Tower Shop Bay 1: Caltrans QA Inspector observed two workers for ZPMC grinding and preparing the root weld pass for magnetic particle testing. The tower skin plates that are joined to from the splice weld joints are identified as SA16, P149, P151, P150, P123, P124 and P661. The splice welds are identified as SSD1-SA16 F/G- 1, SA8, 7A, 3, 109A, 110 and 112A. That forms one continuous weld. Caltrans QA observed, American Bridge/Fluor (ABF) inspector, Mr. Wei Jian Bo monitoring the activities at the work station. ZPMC QC Inspector, Mr. Li Xiu Yang stated that after the preparation of the root pass weld, ZPMC will magnetic particle test the weld for soundness. Caltrans QA witnessed ZPMC QC magnetic particle testing of the root pass weld and appeared to be in compliance with contract requirements. The following digital picture illustrates the preparation of the root pass weld.

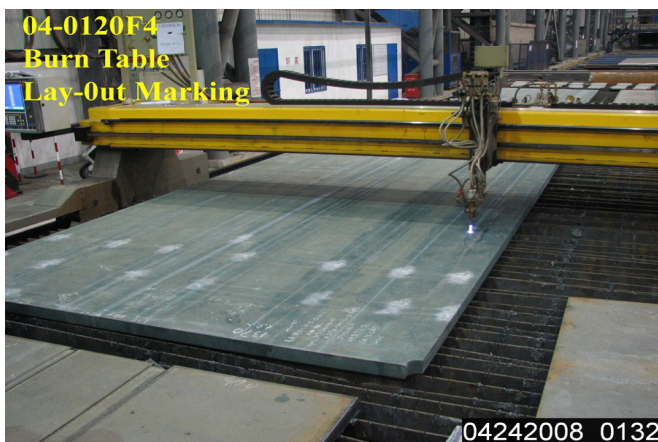
| 2 | Tower Skin Plate | NA | NA | Burn Table Lay-Out |

New Tower Shop Bay 1: Caltrans QA observed the laying out of lay-out lines at the ZPMC burn table. The burn table gantry is equipped with a device, attached in tandem to the cutting nozzle with indelible ink marking system that transposes the marked line onto the surface and the dimensional location of the marking, computer generated. The tower plates observed being layed out are identified as SA151 (S), SA117 (S) and P14 (S). The following digital picture illustrated the burn table and the laying-out of lay-out lines.

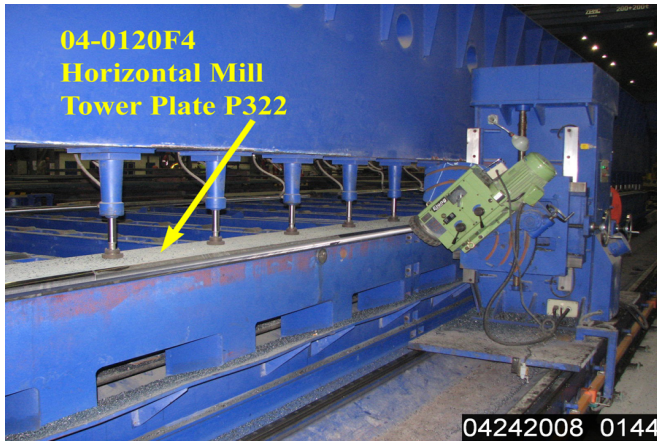
| 3 | Tower Plate | NA | NA | Weld Bevels |

New Tower Shop Bay 1: Caltrans QA observed the beveling of the skin plate double bevels at the ZPMC horizontal milling machine. The tower skin plate is identified as P322. Caltrans QA met with mill operator at the workstation and verified the machined bevels per work instructions at the workstation. These dimensions were referenced to the approved drawing and were in conformance with the dimensional requirements. The following digital picture illustrates horizontal mill and plate beveling.

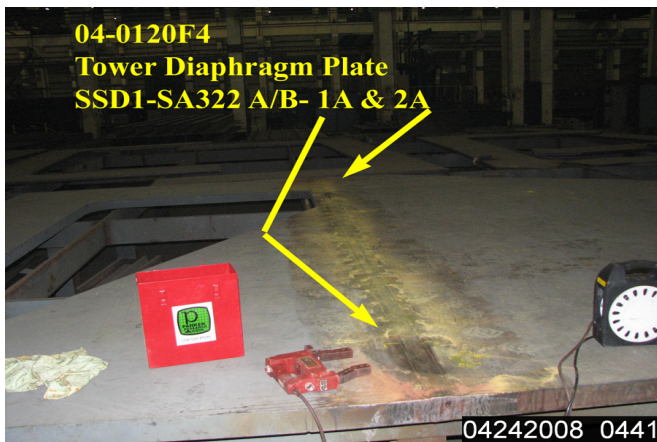
| 4 | Tower Diaphragm Plate | NA | NA | QA-MT |

- Bay 4: Caltrans QA performed magnetic particle testing (MT) per ZPMC notification of witness inspection dated April 23, 2008. The subassembly is identified as tower diaphragm plate SA322 A/B, welds 1A & 2A splice weld reinforcement. Caltrans observed that ZPMC QC had inspected the weld and identified the weld as QC accepted. Caltrans QA MT coverage was approximately 10% and performed in conformance with the contract specifications. See Caltrans Magnetic Particle Test Report (TL-6028) dated April 23, 2008 for additional information. The following digital picture illustrates diaphragm plate MT inspection.
